**Flood Control Project Maintenance
Levee Inspections
LMA District Cover Sheet
Spring 2010 Levee Inspection Results**

Reclamation District No. 0108 River Farms

Levee Inspection Report By Mile - Spring 2010

Waterway							Bank	Unit Miles	Inspection Start/End	Inspector
Unit No. 01 Colusa Basin Drain							Left	20.59	04/07/2010 04/07/2010	John Williamson
LMR No.	Levee Mile		Category	Item	Location	Rating	Action/Comment	GPS Latitude/Longitude		Issue No.
	Start	End						Start	End	Photo
1	0.10	20.56	Earthen Levee	Vegetation	WS	M	Control annual grass and weeds on the levee slopes and easements.	38.823100 ° -121.797491 °	39.033603 ° -121.993042 °	2
2	0.10	20.56	Earthen Levee	Vegetation	LS	M	Control annual grass and weeds on the levee slopes and easements.	38.823100 ° -121.797491 °	39.033604 ° -121.993043 °	1
3	1.05	2.54	Earthen Levee	Crown Surface / Depressions / Rutting	CR	M	Keep the crown roadway free of vegetation.	38.828439 ° -121.813635 °	38.836600 ° -121.839358 °	3 Y
4	3.65	4.54	Earthen Levee	Trim / Thin Trees	WS	A	Trim trees to at least five feet above ground level. Inspector Comments: spray and cut out black walnut trees in rock revetment basal treat stumps; trees are be on the 2

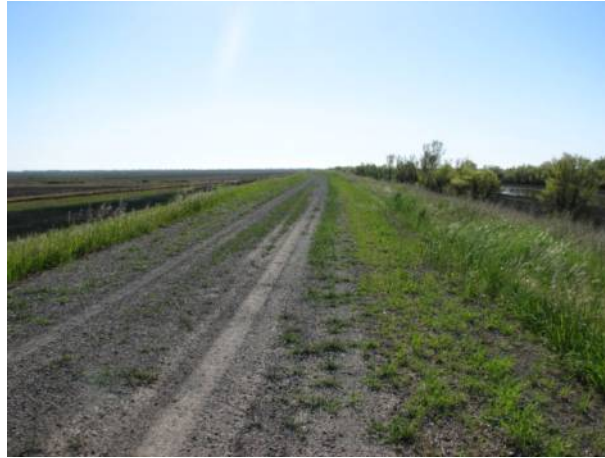
Levee Mile Report Line	3
Start Levee Mile	1.05
End Levee Mile	2.54
Location	Crown
Category	Earthen Levee
Item	Crown Surface / Depressions / Rutting
vegetation on crown	
johngw_s_20100408_112.jpg

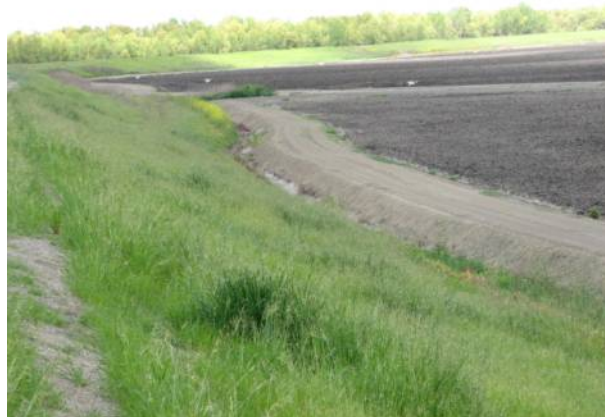
Levee Mile Report Line	14
Start Levee Mile	18.88
End Levee Mile	19.60
Location	Land Side
Category	Earthen Levee
Item	Encroachments
Ag. ditch	
johngw_s_20100316_023.jpg

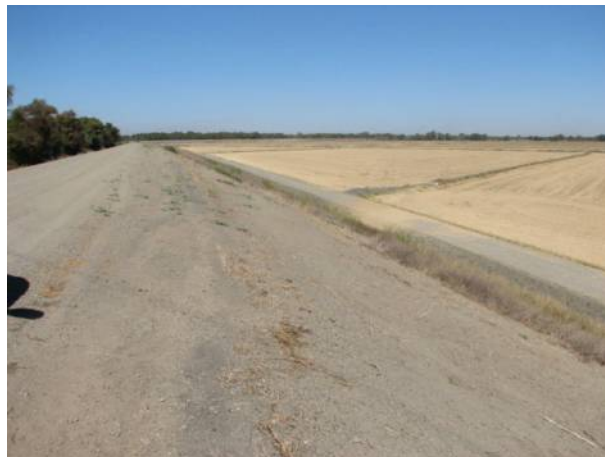
Levee Mile Report Line	14
Start Levee Mile	18.88
End Levee Mile	19.60
Location	Land Side
Category	Earthen Levee
Item	Encroachments
Ag ditch along toe of landside	
johngw_s_20100316_024.jpg

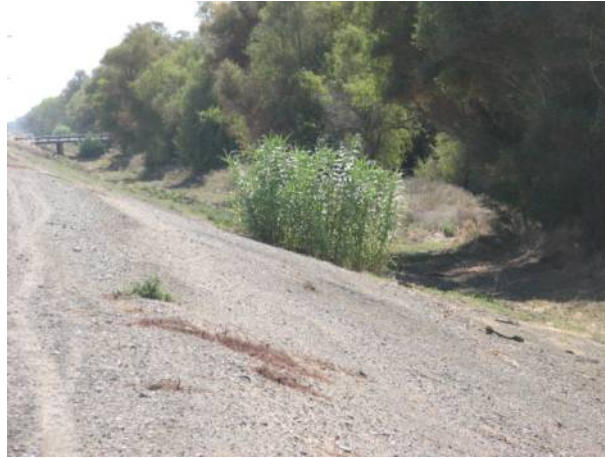
Levee Mile Report Line	15
Start Levee Mile	19.10
End Levee Mile	19.10
Location	Water Side
Category	Earthen Levee
Item	Vegetation

Arundo on slope

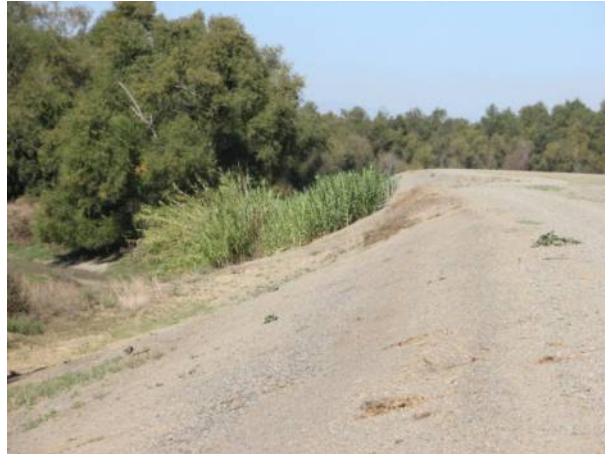
Levee Mile Report Line	16
Start Levee Mile	19.27
End Levee Mile	19.27
Location	Water Side
Category	Earthen Levee
Item	Vegetation

more Arundo on slope
